## **THE INDIAN OCEAN TSUNAMI AND ITS IMPACT ON ANDAMAN ISLANDS: A DETAILED POST-TSUNAMI FIELD STUDY**

### **Abstract**

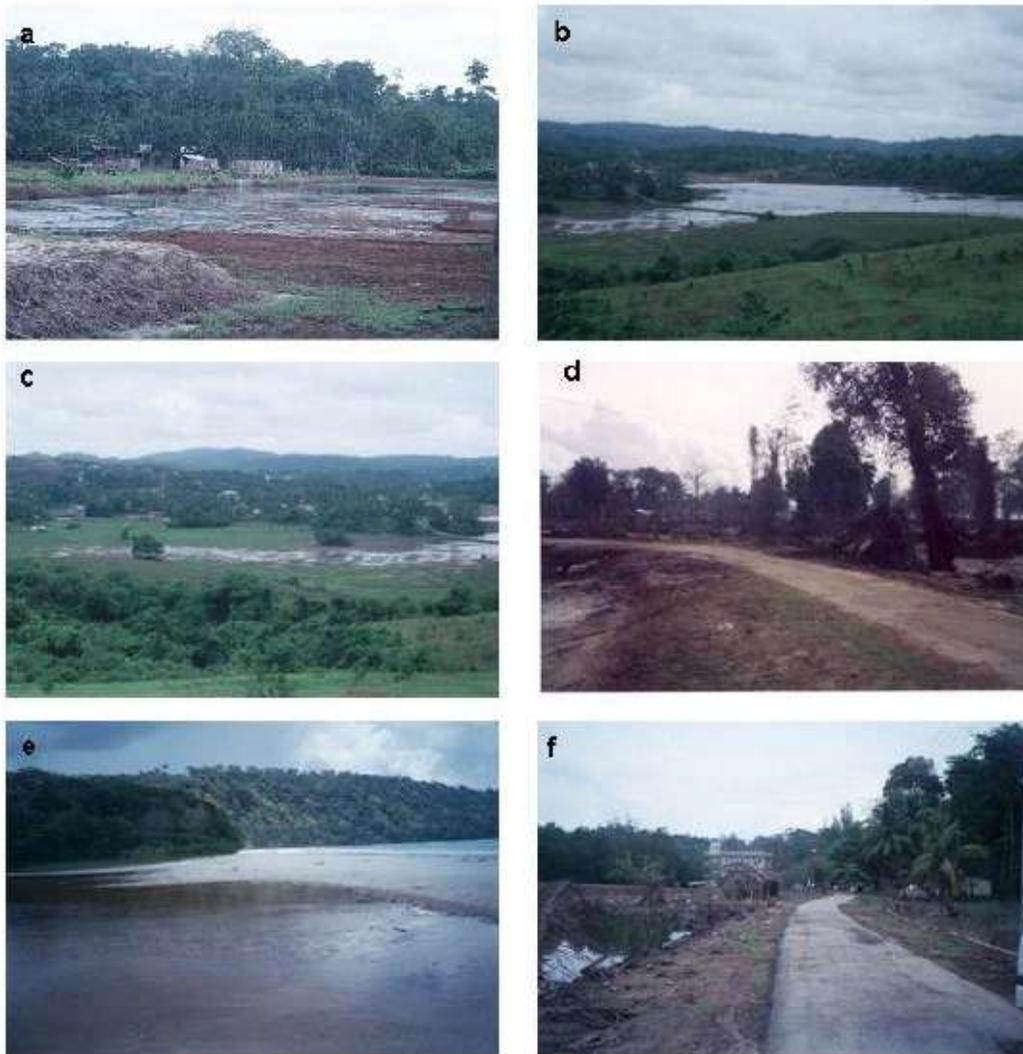
**Figure.3.** (a, b, c) Shows the stagnation of Tsunami water in the agricultural land and low lying areas in Port Blair in the South Andaman (d) Tsunami water which damage the buildings in the Hut bay, Little Andaman (e) Stagnation of Tsunami water in Radha Nagar Beach, Havelock Island (f) Tsunami devastation in the landward and stagnant of tsunami water in part of Wandoor.

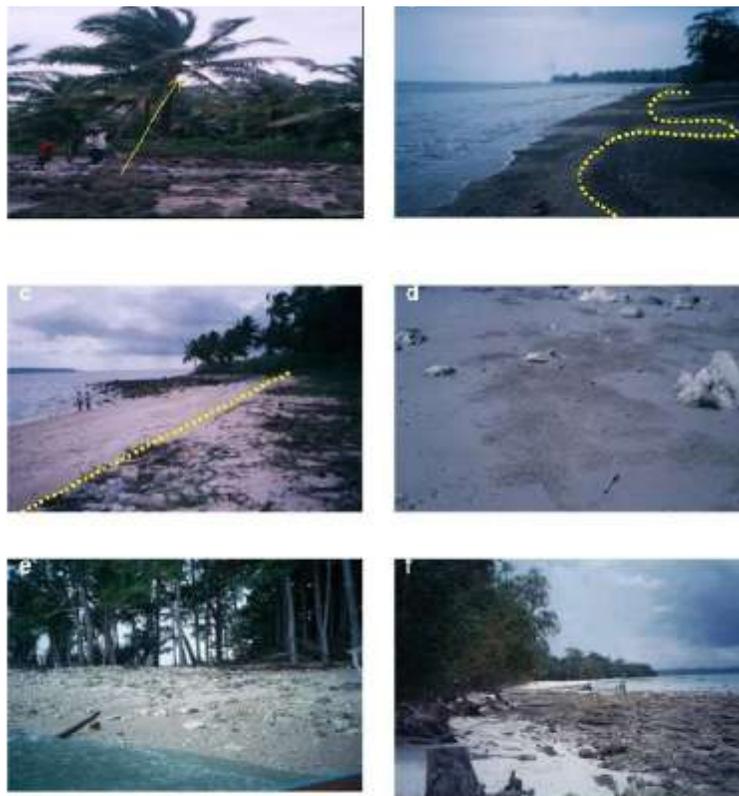
**Figure.5.** (a) Height of Tsunami Waves is shown by the local peoples which is approximately 7 m (b) Debris has been deposited by the tsunami waves (c) Gravels get accumulated on the beach (d) imprints shown by minute organisms (meiobenthos) (e) Extensive corals have been deposited on the beach (f) Uprooted trees in a rocky beach.

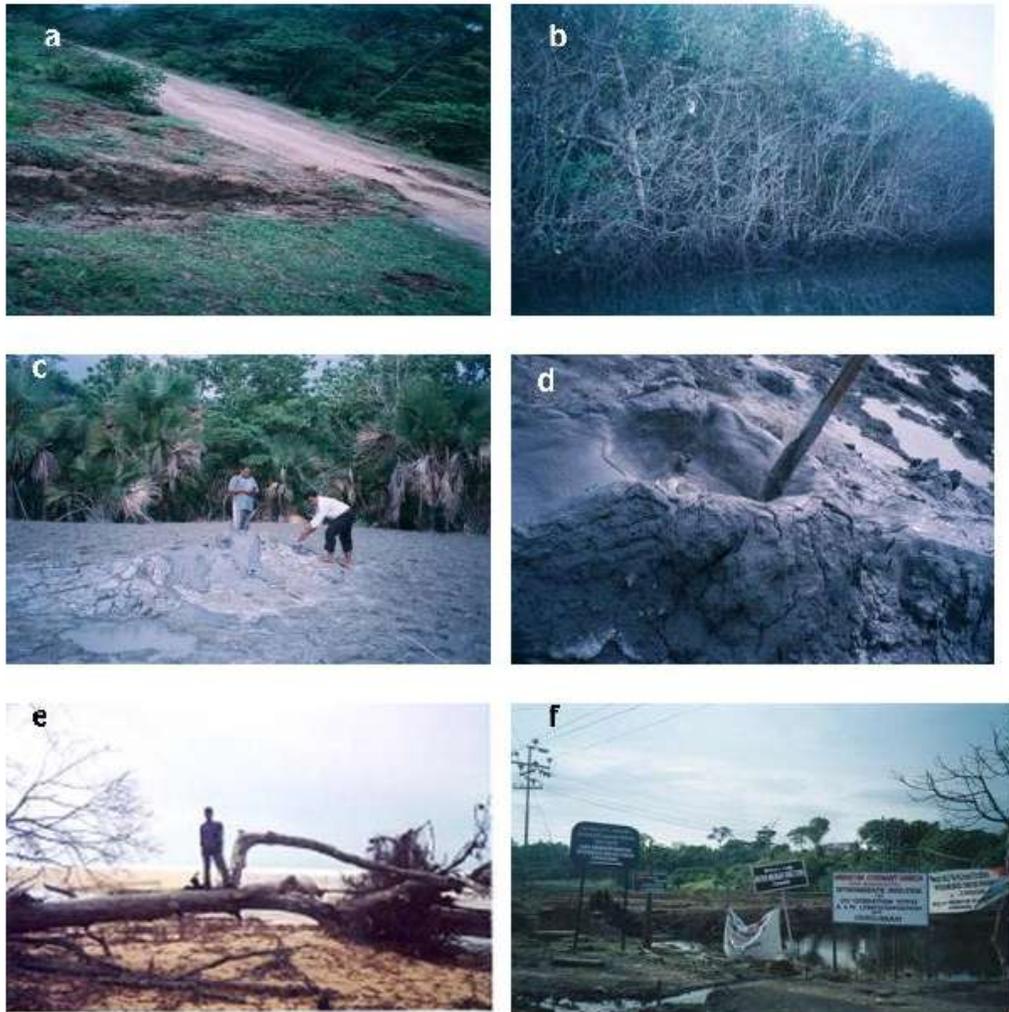
**Figure.6.** (a) Shows the impact of cracks on the ground in Middle Andaman (b) Devastation of mangroves in the sea front part of Baratang (c, d) An active mud volcano in Baratang Island after quake. (e) The uproots are seen in the Hut Bay, Little Andaman (f) rehabilitation in Chouldhari.
